BMAA Defect Alert #0059: P&M Aviation Ltd SB142 – Luff line Attachment Webbing – Issue 2

SB142 – Inspection of Luff line attachment Webbing

SERVICE BULLETIN NUMBER 142, ISSUE 4.

TITLE	Luff line attachment webbings.
CLASSIFICATION	P&M Aviation have classified this bulletin essential.
COMPLIANCE	For sails over 200 hours airtime, Inspection before further flight.
APPLICABILITY	Pegasus XL- Q, Quasar, Quantum, Quik, Mainair Gemini Flash2A, Blade, P&M Quik, Quik GT450.

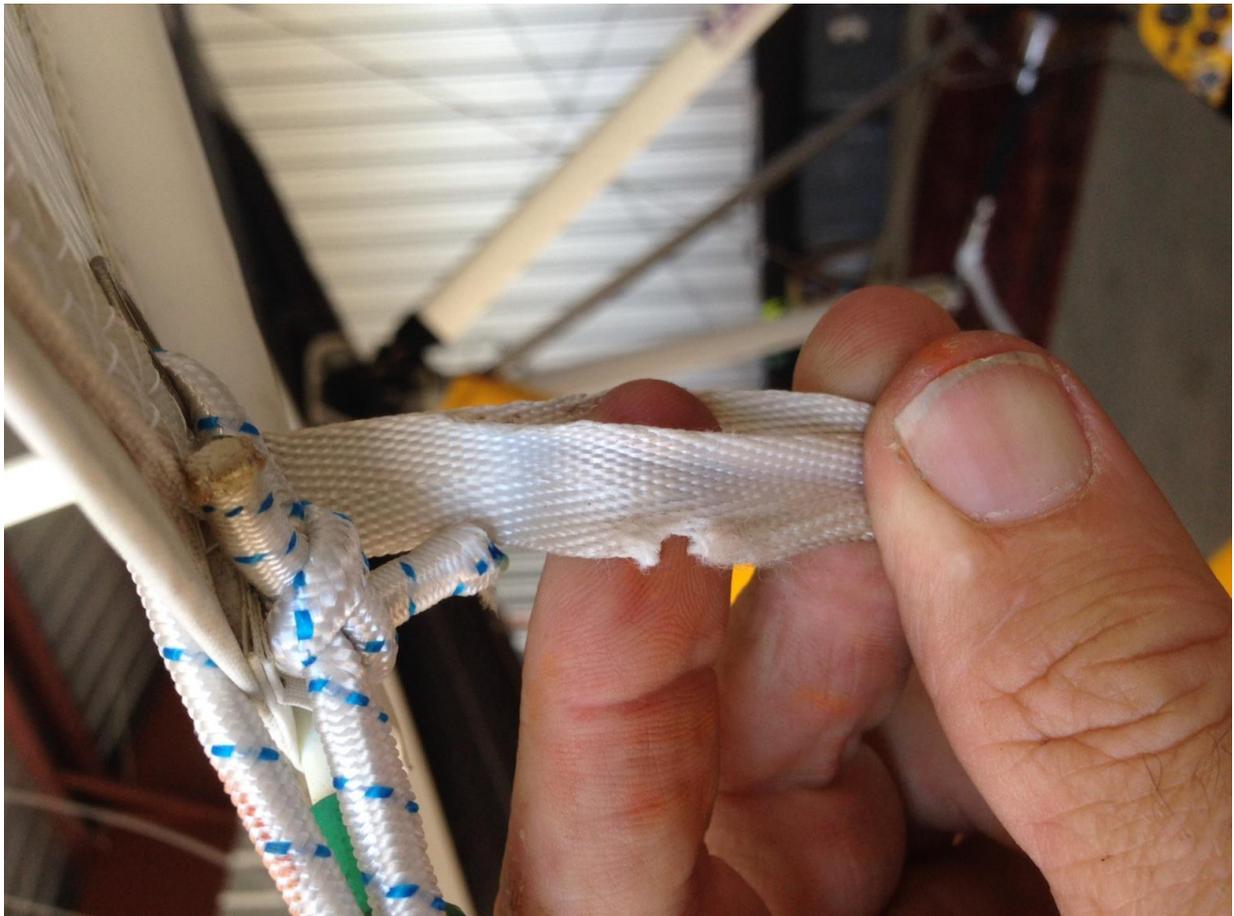
It has been observed that some luff line webbing attachments failed due to chafing on the eyelet through which it passes. Thankfully this happened during taxi and not in the air.

Example of a non-serviceable webbing attachment.

The bulletin details methods for preventing chaffing and also a back-up attachment method using braided cord (available from P&M).

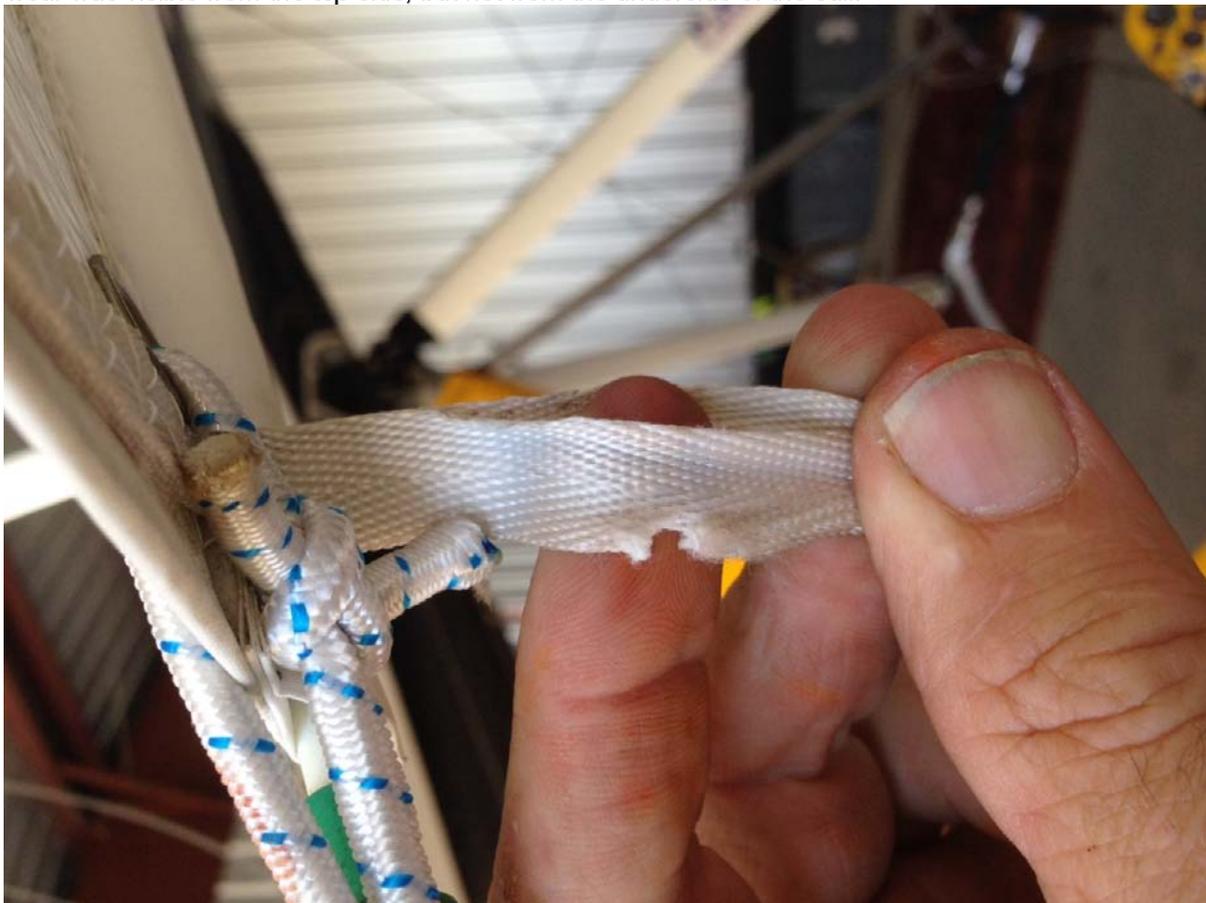
The port inner luff line attachment webbing failed on a GT450 wing with 620 hours airtime during taxiing.

The polyester webbing loop had chafed against the chrome plated brass eyelet. The webbing wear was visible from the top side, but not from the underside of the sail.

Fig 1 example of damaged webbing when removed from the eyelet.

A detached luff line is hazardous as it may go into the propeller. Pitch stability in a steep dive or in turbulence would also be compromised.

If the webbing is damaged, it must be replaced before further flight and any ridge removed from the eyelet. Alternatively, if facilities are not available, the following backup load path may be installed:

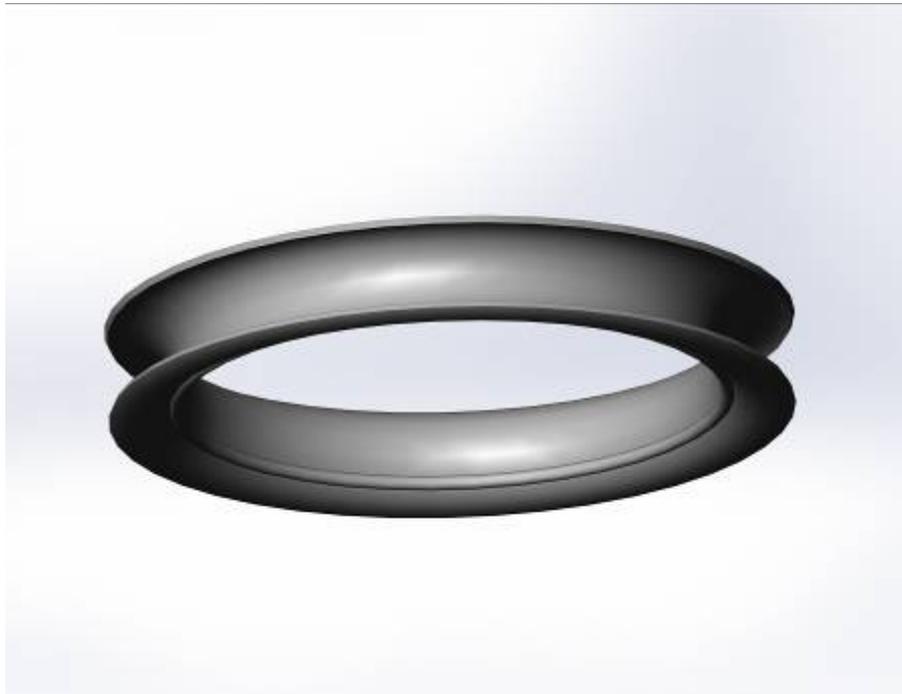
It appears that the eyeleting process has been forming a ridge inside it capable of damaging the webbing. New tooling has been introduced at the Factory to prevent recurrence of the problem.

Fig 2 ridge at the bottom of the eyelet.

It is recommended to remove the luff lines and inspect the inside surface of the eyelets. If there is a ridge, it may be removed e.g. with a Dremel tool or fine file. The inner surface should be polished with a length of cord or webbing and a fine abrasive (metal polish or toothpaste) to leave a smooth surface. Try to keep polish residue off the sail.
