**BMAA Defect Alert #0068:** P&M Aviation Ltd SB147 - Rigging cables with roll swaged end terminals

**Rigging Cables with Roll Swaged End Terminals – Inspection / Replacement**

**Service Bulletin 147**

**SERVICE BULLETIN NUMBER 147, issue 1.**

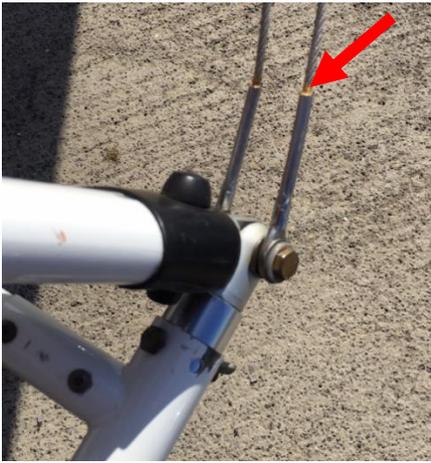
A P&M GT450 in a flying school had a partial failure of a lower side rigging cable (Part No. YQD-045) when recovering from a spiral manoeuvre, within the limits of the flight envelope. These cables are arranged in pairs, to give a backup load path. The second cable carried the load and the aircraft landed safely. This is the only P&M production lower side cable failure we have been aware of since 1984. See fig 1. for cable definitions. The partial failure was at the edge of the roll swaged terminal end shown in fig 2. The alternative cable terminations using Nicopress sleeves and thimbles allow more progressive flexing of the cable. See fig 3.

Fig 2. Overall general arrangement of the GT450 lower side rigging cables with roll swaged terminal ends. The arrow shows the point of partial failure. The attachment bolt at the control frame knuckle should be just loose enough to allow each cable to align with the load. Note the plating on the bolt head is shiny in this example.

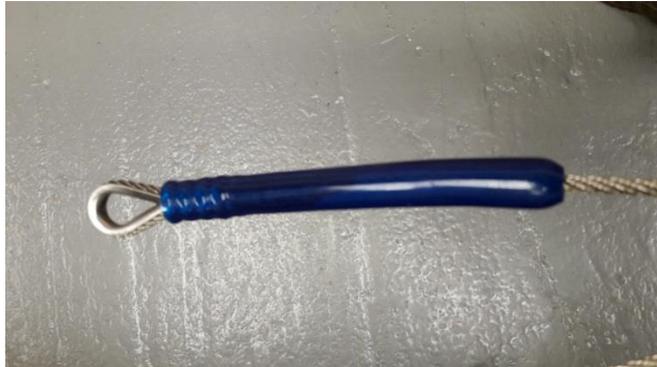
Fig 3. A thimble and Nicopress sleeve type fitting. The blue plastic shroud can be pulled back for inspection of the sleeve.

Replacement GT450 lower side rigging cables will be provided as a kit featuring thimble and sleeve type ends and a longer control frame knuckle bolt (minor modification M313). For cables with thimble and sleeve type ends, replacement at 750 hours/7 years is recommended but not mandatory, provided detailed inspection is carried out at each permit revalidation.

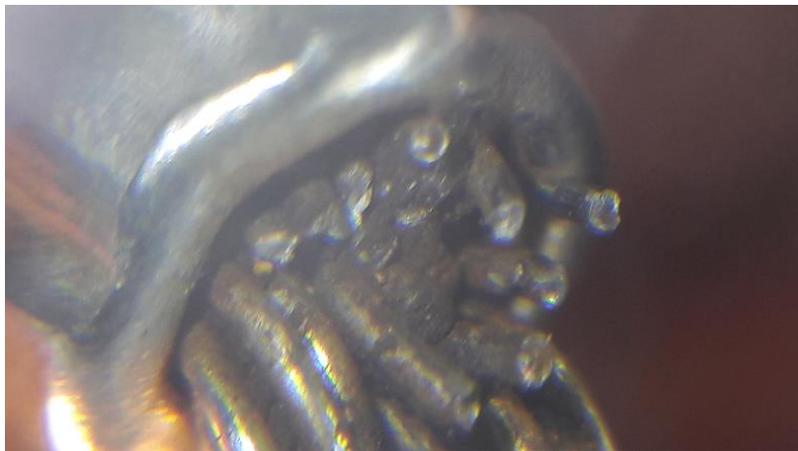
The cable fitting was at the bottom end of the cable, where solutions can wick down it and collect. The strand failures were caused by bending and tensile fatigue because of cracks propagating from scratches and corrosion pits on the surface. See figs 4 & 5.

All the remaining cables had broken strands at the edge of the roll swaged terminals. Some of these strands had been failed for some time, as shown by discolouration of the failure surfaces. The cable is 7 cores of 7 strands construction.

Fig 4. Magnification of edge of the roll swaged terminal of the partially failed cable. Note dirty surfaces of old failures and corrosion marks especially in the central area, which is hard to inspect externally. Several strands had been broken for some time before the failure.

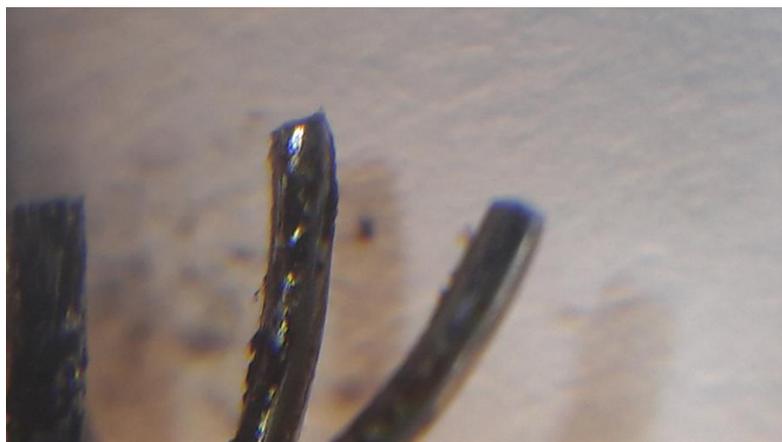
The incident GT450 lower side rigging cables had been in use for 1050 hours and 9 years. The aircraft had been subject to an accident and rebuilt once in its life. It was also operated quite near the coast where it is probable that sea air chlorides could have affected the material. There were corrosion pits in the S316 stainless steel material which accelerate fatigue failures. CLSCC (Chloride Stress Corrosion Cracking) is known to affect stainless steel.

Fig 5. Failed cable strands showing wear grooves and corrosion pits.

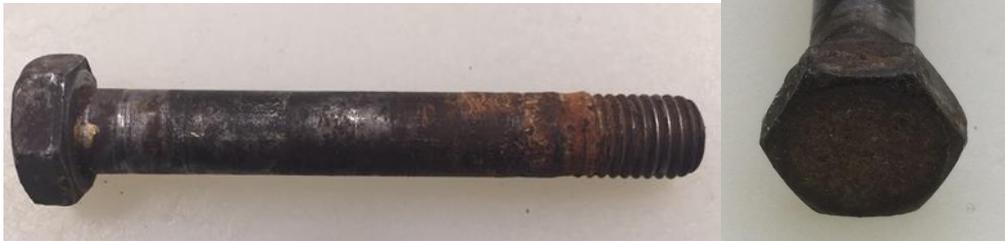
Fig 6. The corroded bolt (Part No. FBA5-21A) that held the partially failed side cable to the control frame.

As can be seen from Fig 6, this bolt displays clear evidence of corrosion and pitting. This is indicative of the general environment in which the aircraft has been operated. This also MAY be indicative of the probability of corrosion occurring within the cable itself. The corrosion on the bolt head is not uncommon for such fittings that are exposed to a salty atmosphere over a long period of time. A clean and bright bolt may well indicate corrosion of the cable is less likely to be an issue.
